Schwenk - Cement Factory - Germany

Cement factory SCHWENK at Bernburg /East Germany / Inspections on ZINGA after over 10-years after application and submission under rough production conditions.

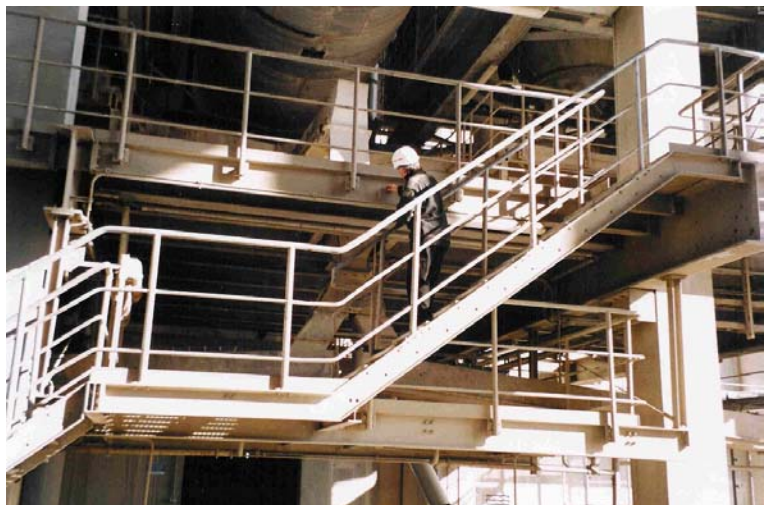
In February 2003, the condition of the ZINGA layer was inspected. On the pictures you can see that the ZINGA is still in [perfect condition](#) and shows no trace of rust [after more than 10 years](#). The customer is very satisfied with ZINGA.

At this moment there is [no need for touch-ups](#).

Later on, the ZINGA could be very easily recharged simply by applying a new layer on top of a cleaned surface !

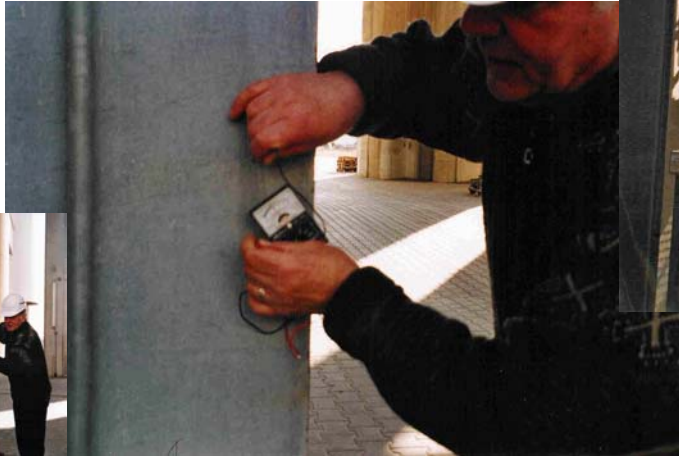
Layer thickness decrease :
5 μm per year

On the weathered side of the plant, where abrasive media and rain wash the surface clean, the ZINGA layer thickness has decreased from 120 μm to 70 μm . This comes down to 5 μm a year, which is surprisingly good under these hard environmental conditions.

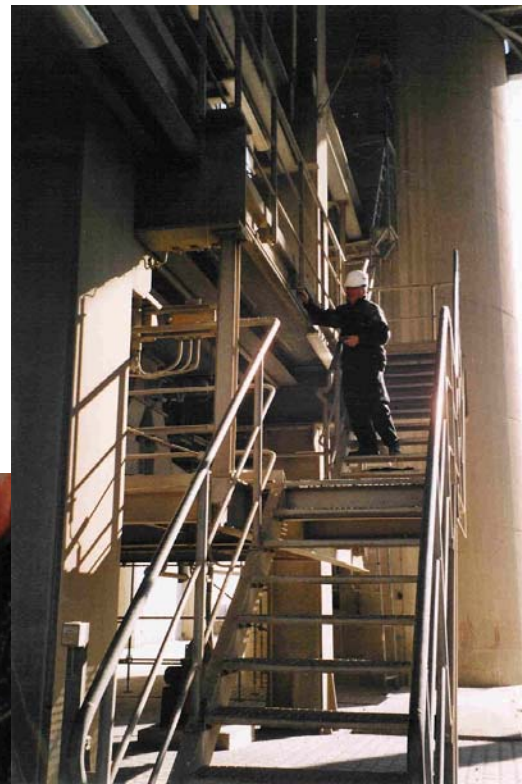
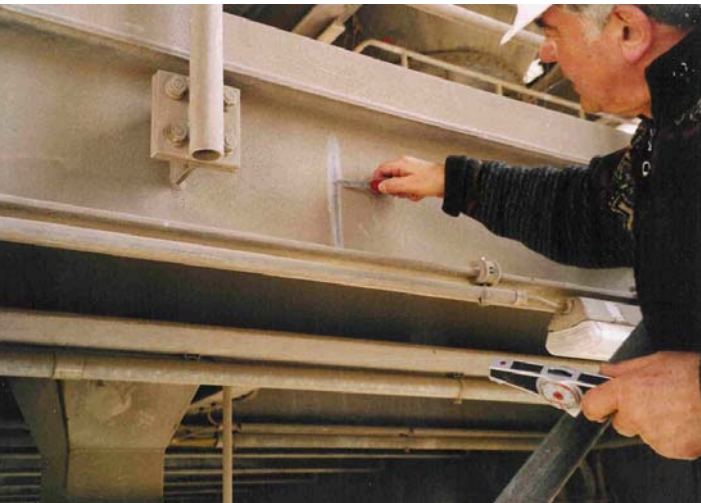
Layer thickness decrease :
0,5 μm per year !!!

On the other side of the plant however, where a thick layer of dust has attached itself to the ZINGA, the layer thickness has only decreased from 120 μm to 115 μm . This is merely 0,5 μm per year : almost unbelievable !

On this picture the dust is being removed and the intact ZINGA layer becomes visible.

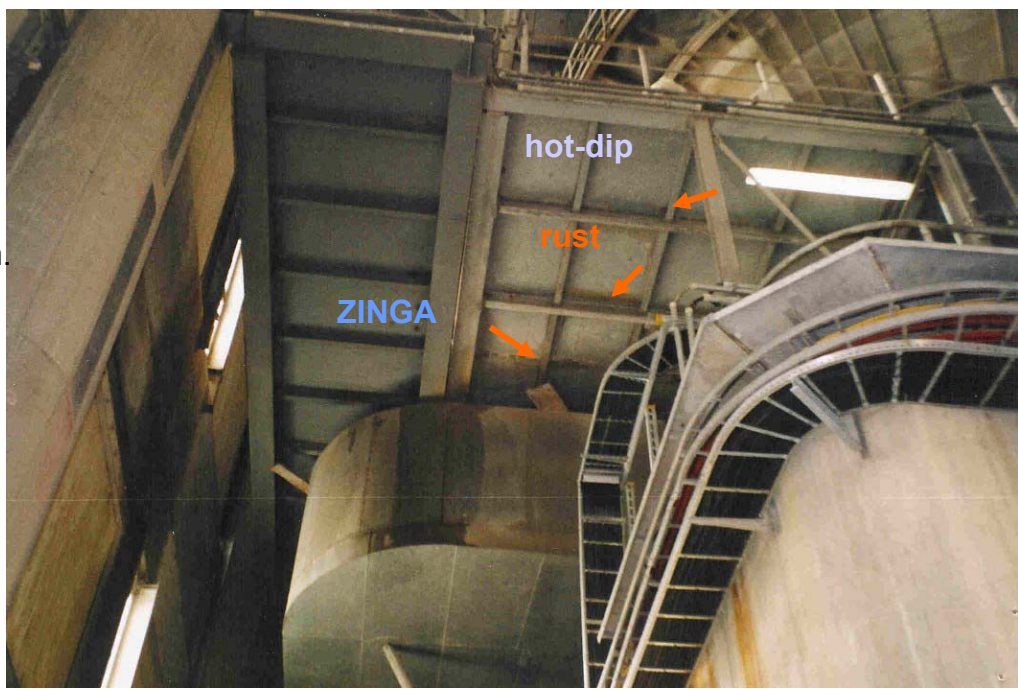
The dark grey on these higher installations is ZINGA, found in perfect condition.

The light grey is hot-dip galvanisation, where the beginning of rust is visible.
