Killybegs Fishing Pier - Immersed Pier Legs - Ireland

Department of the Marine and
Natural Resources
Killybegs FHC
Refurbishment of Piles in Landing Pier
and Blackrock Pier
Post Maintenance Inspection

Type of intervention	INSPECTION
Object	Piles of Landing Pier and Blackrock Pier
Location	Killybegs Harbour, Ireland
Date inspection	14/07/2003
Re-inspection	First inspection after 3 years of service.

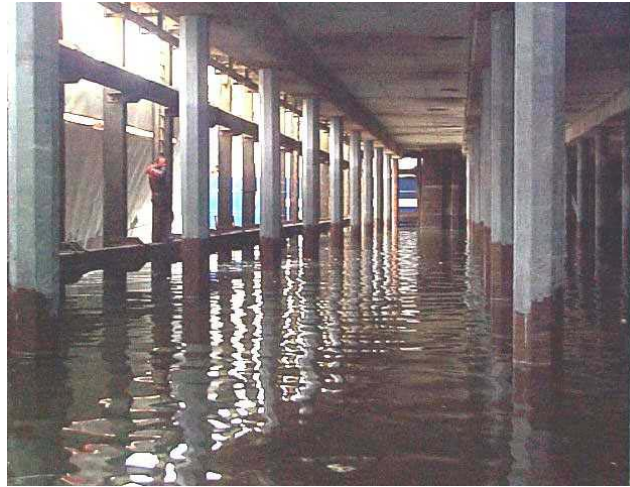
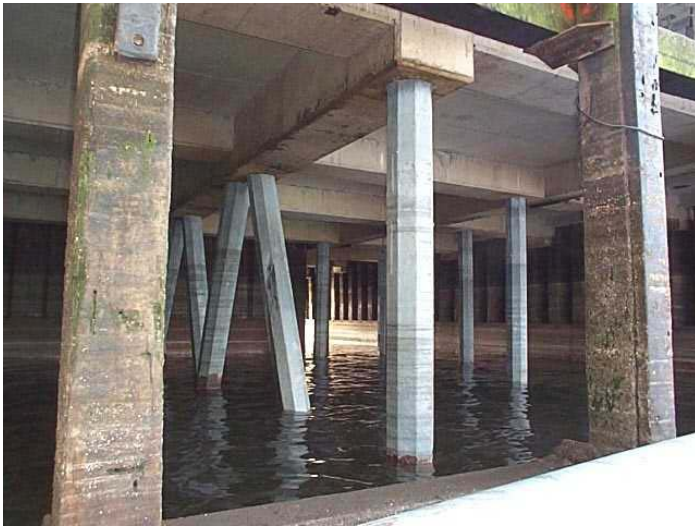
These pictures of the pier legs were taken in August 2001 : one year after the application. The ZINGA is holding perfectly with no rust showing. Any marking on the legs is either seaweed or harbour contaminants.

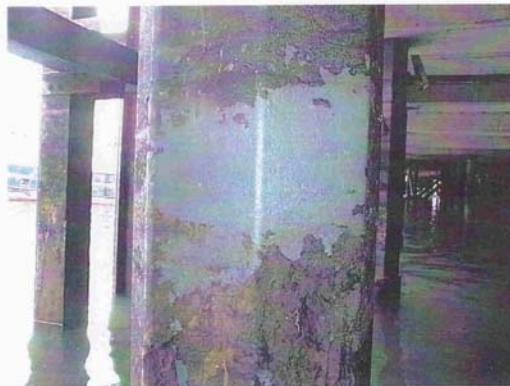
Plate 1. Area of pile cleaned for inspection

When the DFT readings taken during the inspection of the Zinga coating, see appendix A, are compared to those taken at completion of the works no significant change can be seen.

The general condition of the Zinga coating was found to be good with only small amounts of rusting found in areas where very limited access had prevented proper preparation and application, i.e. to the bottom of the piles to row A, that are surrounded in rocks and the tops of the piles to row Z which are surrounded in steel work. The hardness of the coating was

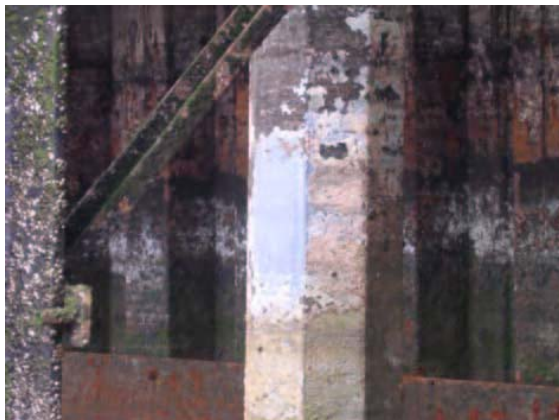
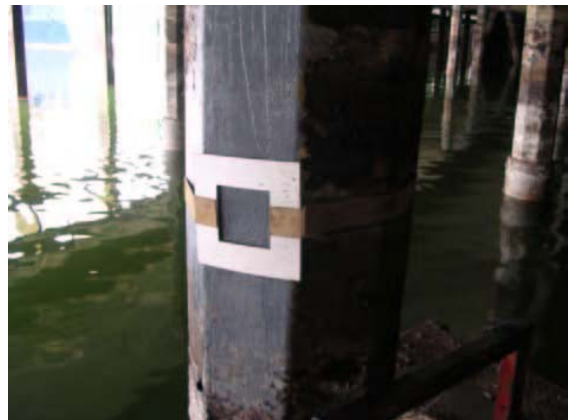
Brief conclusion	See paragraph
Some minor repair work has to be done on piles with areas difficult to reach. The cleaning of the reference piles with HP (warm) water didn't give any problem. The all-over dry film thickness hasn't change significantly.
