Kalvoya Bridge - Norway

Report
 Layer-thickness per 23.02.2000
 Kalvoeya Bru

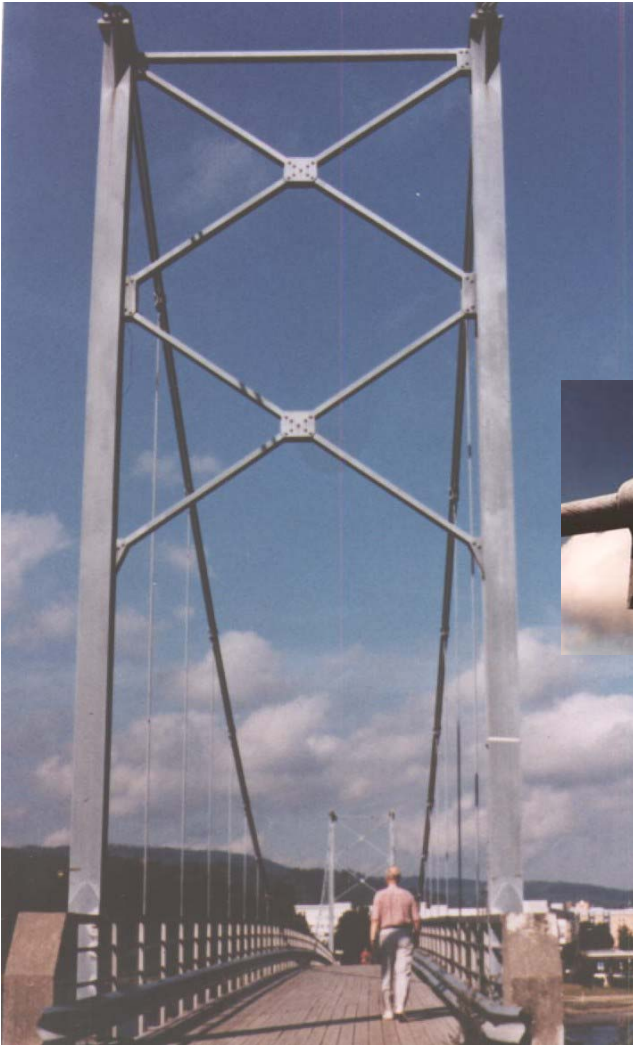
In 1985 ZINGA was applied by brush on the steel structures of the Kalvoya Bridge in Norway. Paint gloves were used for the carrying cables.
