Schwenk - Cement Factory - Germany

Cement factory SCHWENK at Bernburg /East Germany / Inspections on ZINGA after over 10-years after application and submission under rough production conditions.

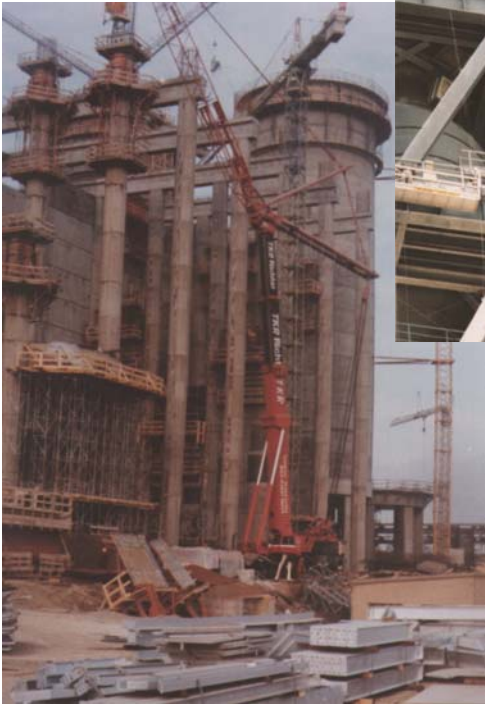
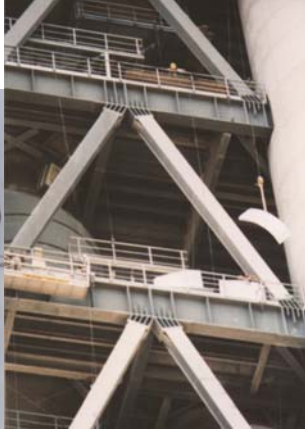
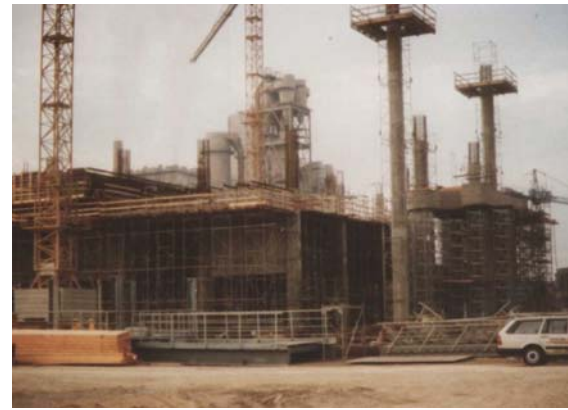
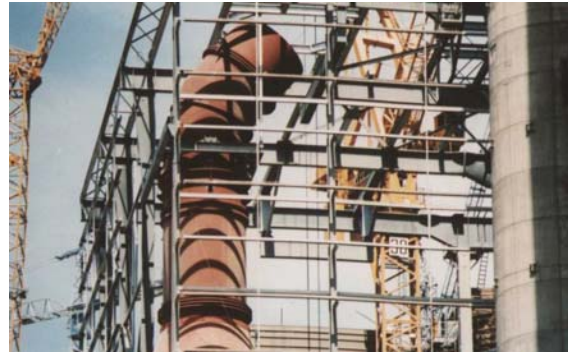
These pictures were taken during construction. 30 tons of ZINGA were used for this application.

In February 2003, the condition of the ZINGA layer was inspected. On the pictures you can see that the ZINGA is still in [perfect condition](#) and shows no trace of rust [after more than 10 years](#). The customer is very satisfied with ZINGA.

At this moment there is [no need for touch-ups](#).

Later on, the ZINGA could be very easily recharged simply by applying a new layer on top of a cleaned surface !
