Kalvoya Bridge - Norway

Report
 Layer-thickness per 23.02.2000
 Kalvoeya Bru

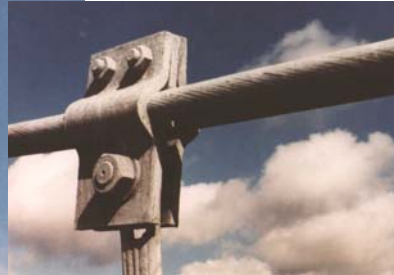
In 1985 ZINGA was applied by brush on the steel structures of the Kalvoya Bridge in Norway. Paint gloves were used for the carrying cables.

ZINGA 2 x 60 µm

In April 1995, 10 years after the application, the Kalvoya Bridge was inspected by the controlling organism Det Norske Veritas (DNV).

In 1995 only 5 Kg of ZINGA were necessary for touch-ups on spots that had been mechanically damaged.
