Killybegs Fishing Pier - Immersed Pier Legs - Ireland

Department of the Marine and
Natural Resources
Killybegs FHC
Refurbishment of Piles in Landing Pier
and Blackrock Pier
Post Maintenance Inspection

Type of intervention	INSPECTION
Object	Piles of Landing Pier and Blackrock Pier
Location	Killybegs Harbour, Ireland
Date inspection	14/07/2003
Re-inspection	First inspection after 3 years of service.

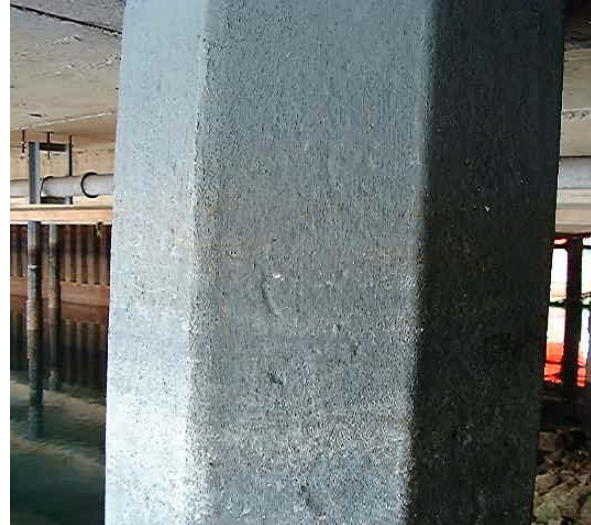
The fishing pier, which supports the factory buildings, is held up by 309 mild-steel hexagonal shaped legs, all approx. 600 mm in diameter.

These pier legs have been in the sea for 25 years and due to the salt and the sulphate reducing bacteria present in the sea water, they were losing up to 2 mm per year off their thickness. The waters around Killybegs are unique because they have the highest rate of corrosion in Europe.

The height from the concrete deck to the water level at low tide is approx. 3 to 4 meter. At high tide, 1,5 to 2 meter of each pile is totally submersed in seawater.

System :

ZINGA 1 x 25 μm + 3 x 40 μm

The piles were prepared by UHP water-jetting and blasting to SA 2.5 with Rz 40 to 60 µm.

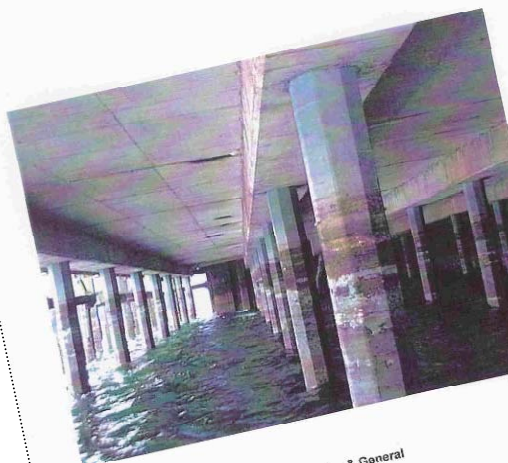
The general condition of the Zinga coating was found to be good with only small amounts of rusting found in areas where very limited access had prevented proper preparation and application, i.e. to the bottom of the piles to row A, that are surrounded in rocks and the tops of the piles to row Z which are surrounded in steel work. The hardness of the coating was
